EAGLE PROPERTIES

.....Home Inspections

Your Future Home Address Here
Southeast, MN 559XX

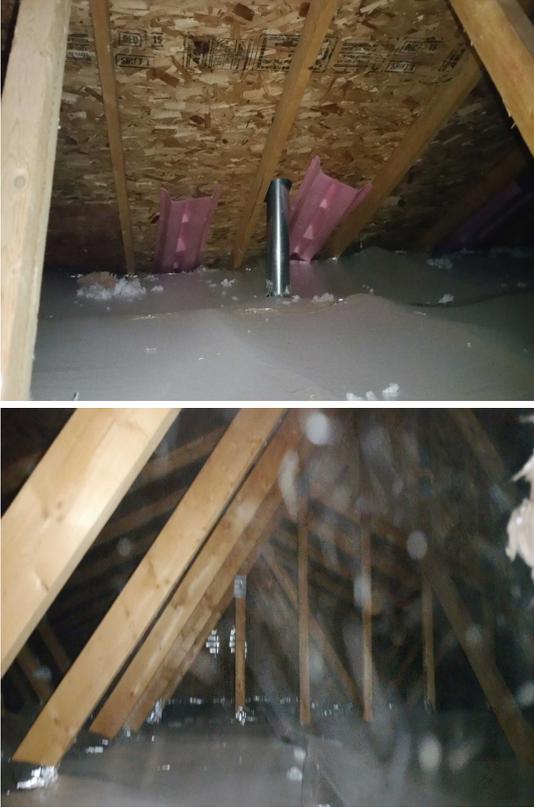
<p>General</p>	<p>1 Check that no plumbing, exhaust or appliance vents terminate in the attic?</p>	<p>✓</p>
	<p>2 Is the attic accessible?</p>	<p>✓</p>
	<p>3 Is the attic free from any sign of decay or damage to the structure?</p>	<p>✓</p>
	<p>4 Is the attic free from any signs of leaks, water damage or humidity?</p>	<p>✓</p>
	<p>5 Is the attic insulated? <i>Fiberglass insulation approximately 12" = R-30.</i></p>

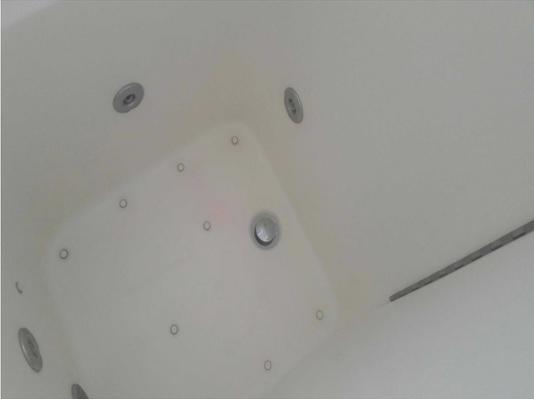
damage?	
Sink Area	16	<p>Are all water exits/drains free of leaks or clogs?</p> <p><i>This item needs action.</i></p> <p><i>Walk in shower drain slow. May need to be cleared with a zip line. This is a maintenance item.</i></p>

Seq	Question
17	Are all water exits/drains free of leaks or clogs? <i>Walk in shower drain slow. May need to be cleared with a zip line. This is a maintenance item.</i>

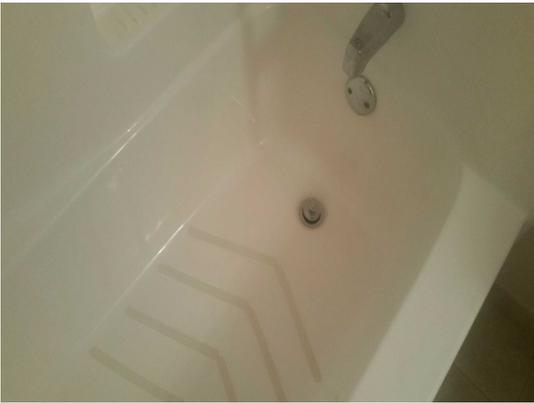
General	12	Are all electrical sockets/plugs working correctly?	✓
	13	If there is an extraction fan, is it working correctly?	✓
	14	Is the radiator/heater clean and working, and free from damage (chips, marks etc)?	✓
Light fixtures	15	Do all lights/switches work correctly and are they free of damage?	✓
Sink Area	16	Are all water exits/drains free of leaks or clogs? <i>This item needs action.</i> <i>Slow shower drain. Clear with zip line. This is a maintenance item.</i>	✗

Seq	Question
17	Are all water exits/drains free of leaks or clogs? <i>Slow shower drain. Clear with zip line. This is a maintenance item.</i>

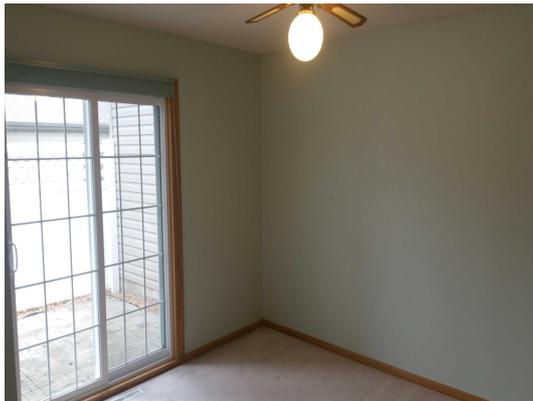
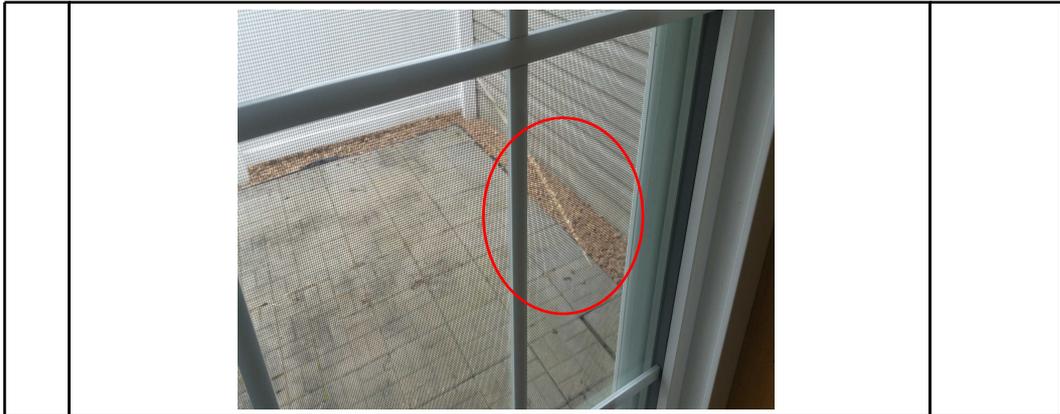
Ceiling	1	Is the ceiling free from damage, uneven surface area, water spots, or cracks?	✓
Door	2	Is the door(s) securely fixed, well fitted and free from damage, or defects?	✓
Floor	3	Is the floor level and free of creaking when traversed across?	✓
	4	Is the flooring material in good condition with no stains or damage?	✓
General	5	Are all electrical sockets/plugs working correctly?	✓
	6	If fitted closets are present, are they free from damage and do all doors/drawers open and close easily?	✓
	7	Is the radiator/heater clean and working, and free from damage (chips, marks etc)?	✓
Light fixtures	8	Do all lights/switches work correctly and are they free of damage?	✓
Walls	9	Is the paintwork free from damage or marks, blemishes, or discolorations?	✓
	10	Is the surface of the plasterwork or plasterboard smooth and even and free from obvious cracks, damage, hollows and/or bumps <i>Patio door screen torn.</i>	✓

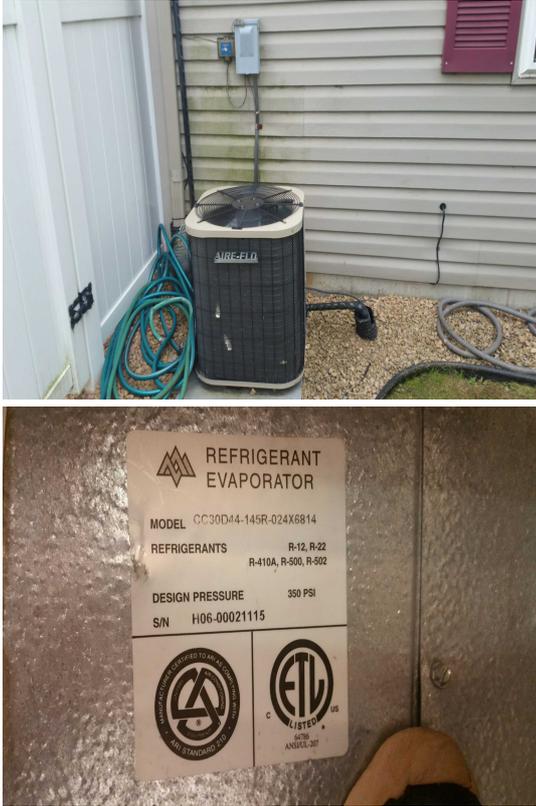
<p>Air Conditioning System</p>	<p>1</p>	<p>Air conditioning unit(s) turns on and cold air is emitted?</p>	<p>✓</p>
	<p>2</p>	<p>Are air conditioning unit(s) free of irregular noises, and visible signs of deterioration? Are de-activating correctly at desired temperature?</p>

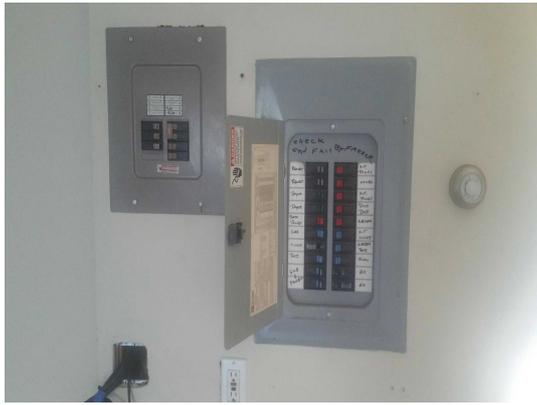
<p>✓</p>
<p>Electrical System</p>	<p>3</p>	<p>Ensure that all electric wiring is not directly exposed?</p>	<p>✓</p>
	<p>4</p>	<p>Is the electrical box easily accessible?</p>	<p>✓</p>
	<p>5</p>	<p>Is the electrical box fitted with breakers (rather than fuses)? Are they labelled and the box covered? <i>100A service, main disconnect at meter bank outside building. Sub panel added neatly to maintain separate circuits for tub upgrade and garage furnace.</i></p>	<p>✓</p>

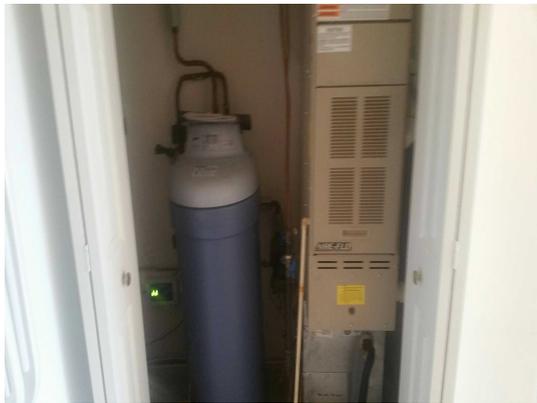
<p>Heating</p>	<p>6 Does the heating system turn on without unusual smoke, or irregular odours? <i>This item needs action.</i> <i>Natural gas furnace high efficiency 92% afue. Garage furnace appears to be the old house furnace, it is connected properly but does not currently light up, this appliances should be serviced by an HVAC technician before appraisal. Water heater is 50 gallons installed in 2012 and in good condition. Water heater drip leg is missing next to gas valve this should be installed to prevent Appliance from clo* *ing with lubricating oil in gas line. House furnace vent on roof is concentric style, but concentric device needs to be raised higher over the roof surface, at least 6 inches higher than currently, to prevent air inlet from being blocked with snow. While this attic ã not accessible, vent may be raised by adding pvc sections directly to the 2" pipes at the utility room. Air conditioner evaporator coil drain hose is lifted over the rigid furnace drain pipe creating a water trap that acumulates water inside the AC pan, should be rerouted to prevent this water trap.</i></p>	<p>X</p>

Seq	Question
7	Does the heating system turn on without unusual smoke, or irregular odours? <i>Natural gas furnace high efficiency 92% afue. Garage furnace appears to be the old house furnace, it is connected properly but does not currently light up, this appliances should be serviced by an HVAC technician before appraisal. Water heater is 50 gallons installed in 2012 and in good condition. Water heater drip leg is missing next to gas valve this should be installed to prevent Appliance from clothing with lubricating oil in gas line. House furnace vent on roof is concentric style, but concentric device needs to be raised higher over the roof surface, at least 6 inches higher than currently, to prevent air inlet from being blocked with snow. While attic may not be accessible, vent may be raised by adding pvc sections directly to the 2" pipes at the utility room. Air</i>

<i>conditioner evaporator coil drain hose is lifted over the rigid furnace drain pipe creating a water trap that acumulates water inside the AC pan, should be rerouted to prevent this water trap.</i>
--	---------------------------------------------------------------------------------------------------------------------------------------------------------------------------------------------------------

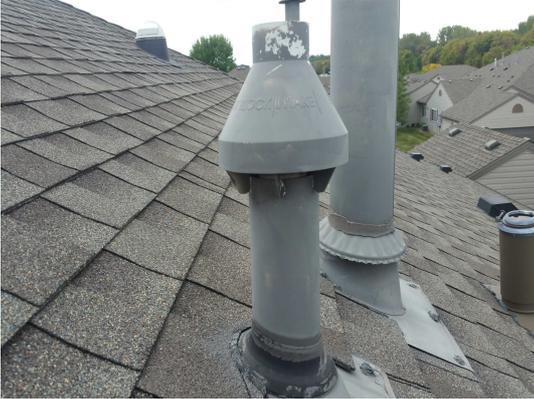
<p>General</p>	<p>1 Are the flashings secure (not loose) at the chimney, roof-to-wall joins or elsewhere?</p> <p><i>Furnace vent short, prone to be blocked by snow on roof and keep furnace from working when most needed or flood appliance heat exchanger with snow melt if not fully blocked. This should be corrected.</i></p>

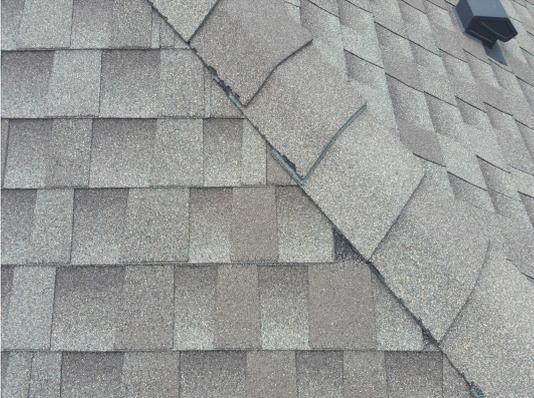
<p>✓</p>
	<p>2 Are the roof shingles (or tiles) free from any signs of damage or deterioration (such as curling, warping, broken edges etc.) ?</p> <p><i>This item needs action.</i></p> <p><i>Asphalt shingles, architectural style. 30 years expected lifetime. Some delamination on edges of ridge caps appears to be material defect and delaminated dimple strikes on surfaces due to large hail. These appear premature and should be communicated to the HOA as repairs may be covered by a recall from the shingle manufacturer or by the HOA insurance.</i></p>

Seq	Question
3	Are the roof shingles (or tiles) free from any signs of damage or deterioration (such as curling, warping, broken edges etc.) ? <i>Asphalt shingles, architectural style. 30 years expected lifetime. Some delamination on edges of ridge caps appears to be material defect and delaminated dimple strikes on surfaces due to large hail. These appear premature and should be communicated to the HOA as repairs may be covered by a recall from the shingle manufacturer or by the HOA insurance.</i>

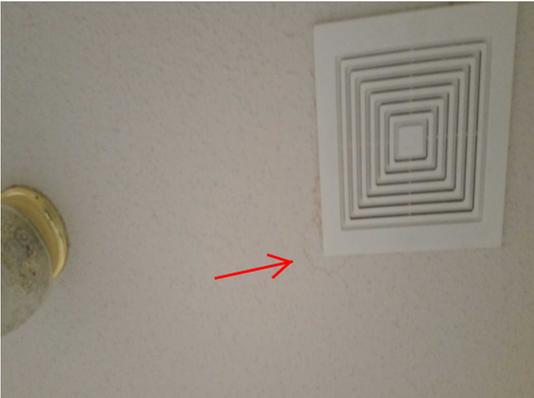
Appliances	1	Has adequate plumbing and extraction holes been provided for appliances?	✓
Ceiling	2	<p>Is the ceiling free from paint bubbles, water spots or any visible items that may indicate humidity buildup?</p> <p><i>This item needs action.</i></p> <p><i>Condensation stains next to exhaust vent. Turn on exhaust fans for 15 minutes after using washer to reduce humidity in laundry.</i></p>

Seq	Question
3	Is the ceiling free from paint bubbles, water spots or any visible items that may indicate humidity buildup? <i>Condensation stains next to exhaust vent. Turn on exhaust fans for 15 minutes after using washer to reduce humidity in laundry.</i>
